Applies To: **1999-02 Odyssey** – ALL without Navigation System
1998-02 Accord – ALL

February 12, 2002

Clock Light Does Not Work

(Supersedes 01-097, dated November 6, 2001)

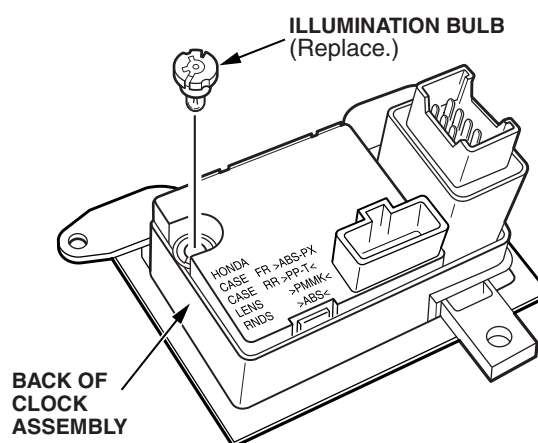
The clock does not light up with the other instrument panel lights.

1. *Odyssey:* Remove the instrument panel (see page 20-68 in the service manual). *Accord:* Remove the clock from the center panel (see page 22-129 in the service manual).
2. Replace the clock illumination bulb.

3. Reinstall the clock or the instrument panel.
4. Set the clock.
