# Mismatched Coil Testing to Simulate Condenser Replacement

## **13 SEER HP Rating with Proper 13 SEER Indoor Coil**

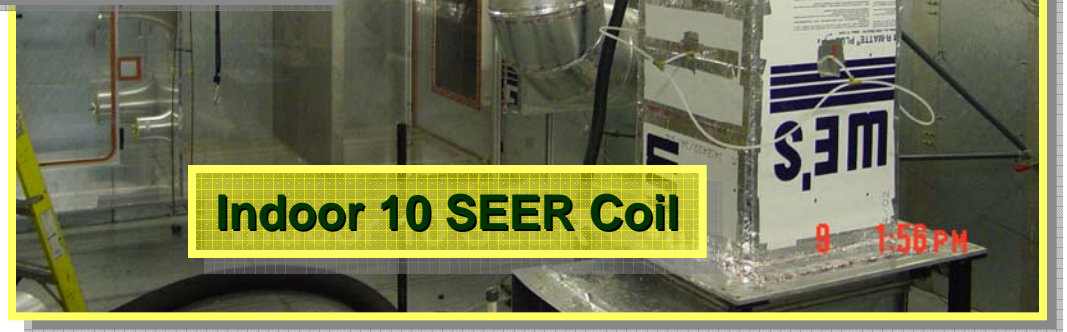
<b>Capacity (BTU/hr)</b>	<b>36794</b>
<b>SEER</b>	<b>13.62</b>
<b>Superheat (service valve) (F)</b>	<b>17.93</b>
<b>Subcool (service valve) (F)</b>	<b>6.08</b>
<b>Liquid press (psig)</b>	<b>222.76</b>
<b>Return gas press (psig)</b>	<b>81.38</b>
