2.23: continued

248 CMR - 145

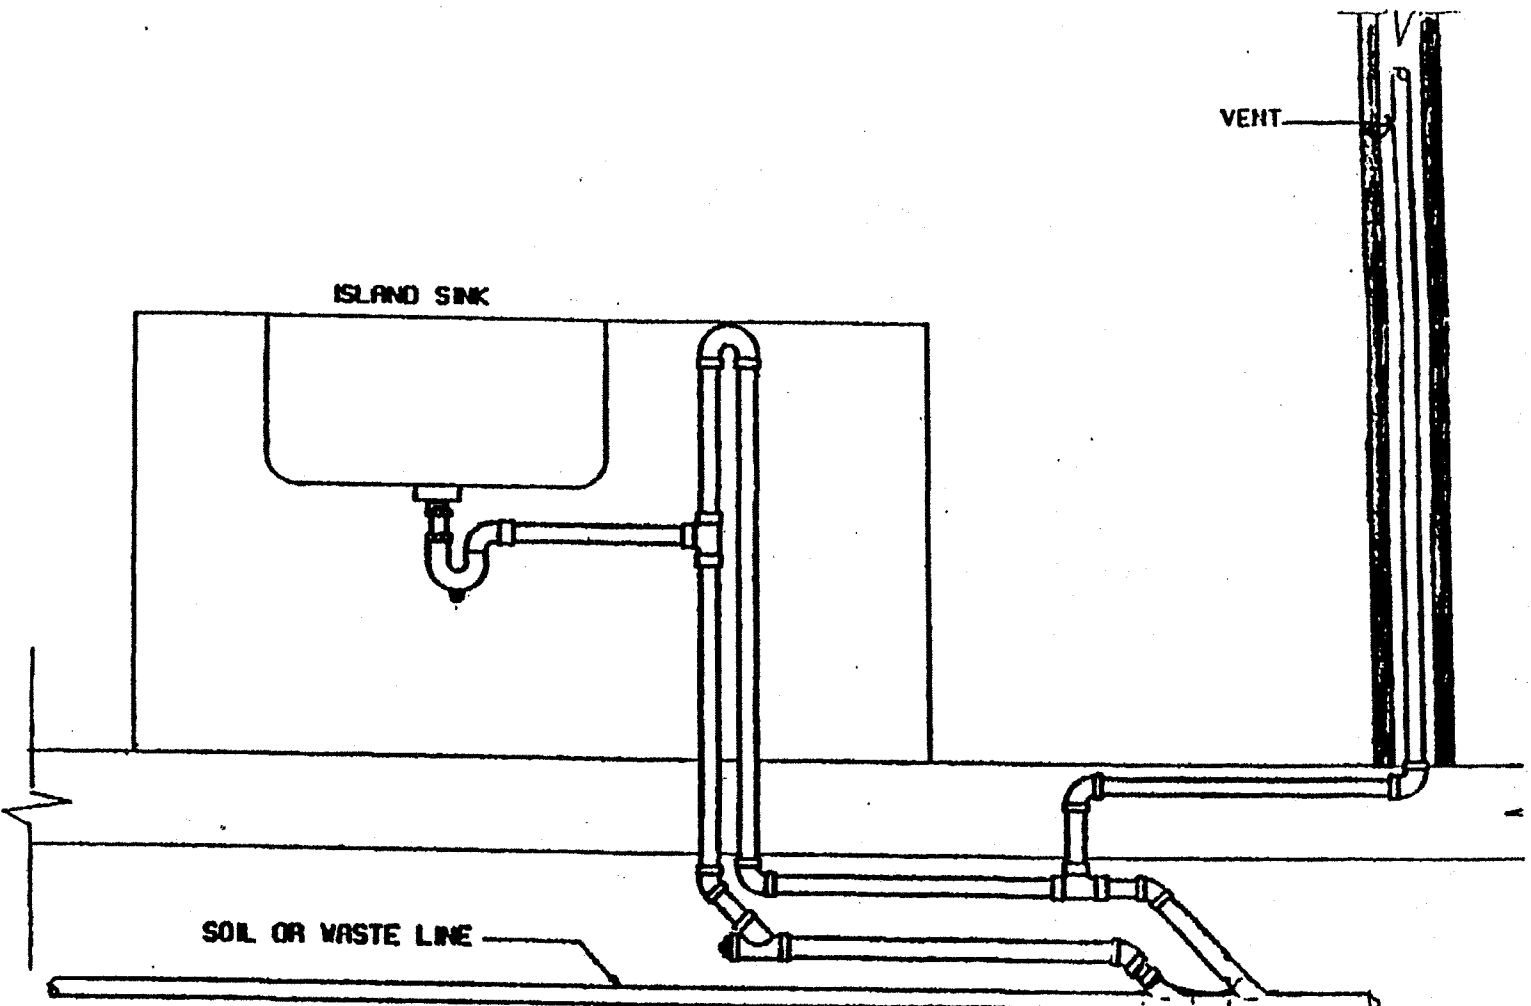
FIGURE 13c

BOW VENT CONNECTING TO HORIZONTAL  
NOT TO SCALE
